# ZOLEZZI DAM

## Italy, 1991

**Works:** lining of the upstream face of a thin concrete arch dam

**Purpose:** rehabilitation of the headworks of an hydropower system.

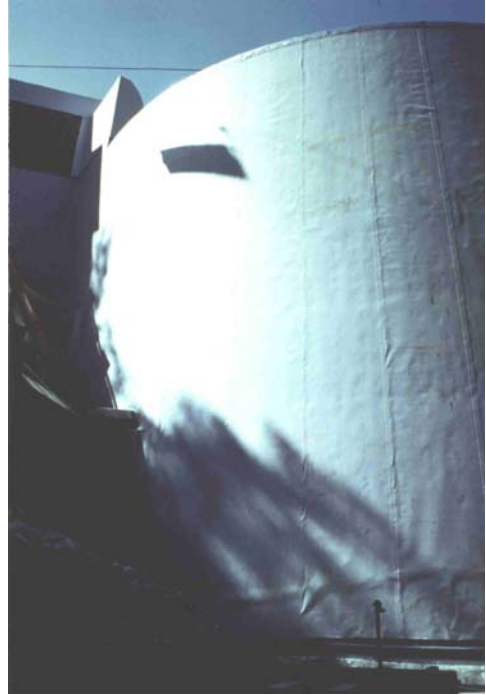
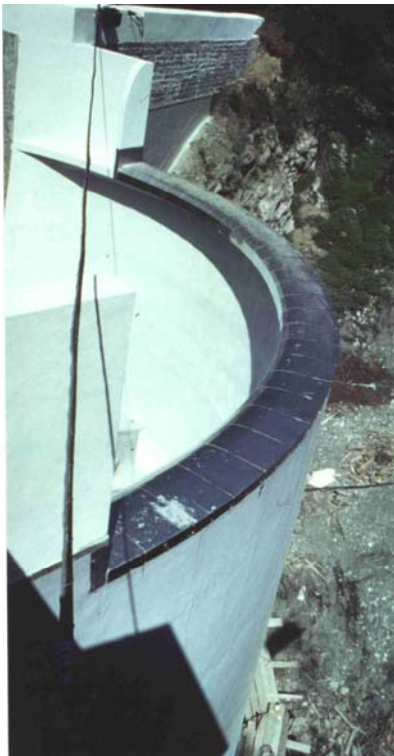
*A steel tube scaffolding was erected on both faces of the dam for sand-blasting and chipping of deteriorated areas. The rolls of geocomposite were unrolled from the top down and were then pressed against the arch so that the geotextile became embedded in the two component adhesive, previously placed on the dam face, before it polymerised. The vertical weldings were done and tested manually. Three different peripheral attachments were adopted for the upper edge, lower edge and the sides using stainless steel strips and studs embedded with epoxy resin, sealants and mortar.*

*Since the dam is over-topped regularly the dam crest was lined with the composite geomembrane (after meticulous cleaning and patching of the concrete sill) and then protected with stainless steel sheets adhered and fixed to the geomembrane.*
