AJIWA DAM

Nigeria, 1996

PROJECT CHARACTERISTICS

Works: Rehabilitation and improvement of an earthfill dam and new spillway.

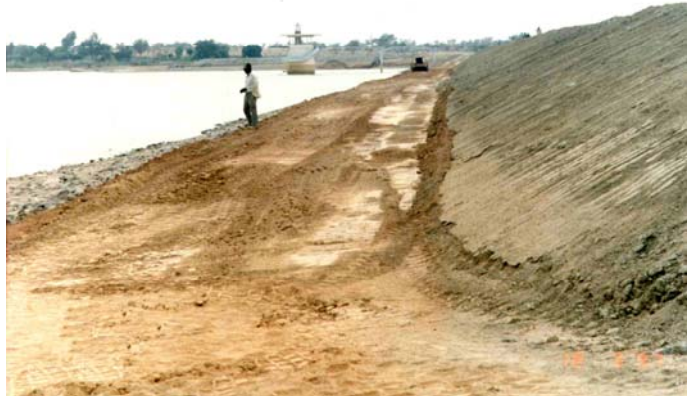
- original dam height: 12 m, rehabilitated dam height: 14.7 m
- original dam crest length: 880 m, rehabilitated dam crest length: 1491.8 m
- Old embankment removed: 45 000 m³
- New fill Added: 95 000 m³

Watertightness: clay core

- foundation: granite and gravelly sand
- original embankment: weathered granite
- new embankment: lateritic soil for the u/s portion and sandy weathered granite for the d/s one

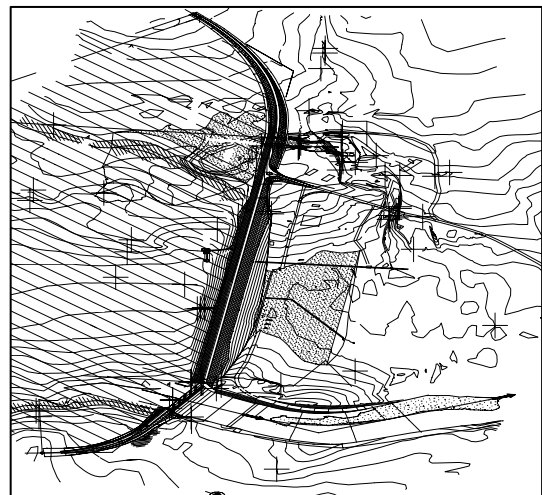
The dam rising implied the construction of completely new wings on both banks, beyond the existing dam. The protection on both u/s and d/s slopes was placed over a geotextile separator. A toe drain, along the lower line of the d/s slope and a counterweight berm, in the lower section of the river, were added. The intake tower was also raised and refurbished. A monitoring system, based mainly on monuments for settlements, horizontal displacement measurements and piezometers, was also implemented. The spillway, 90 m long, is overpassed by a 8 spans, light weight steel bridge.
